SECTION **BRM**
BODY REPAIR

Body Exterior Paint Color

BODY COMPONENT PARTS

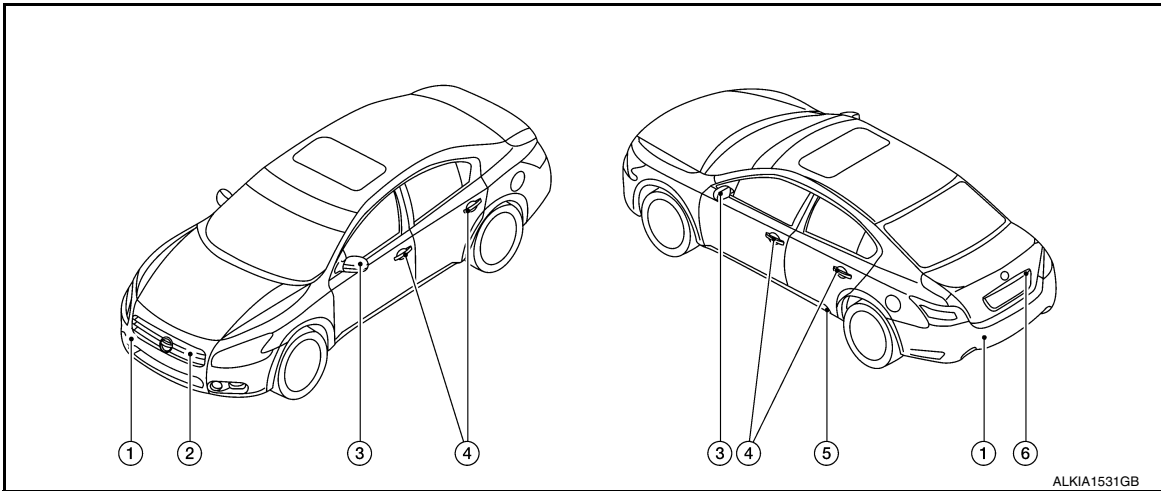
ALKIA1531GB

Component			Color code	CAJ	GAD	KH3	K23	KAD	NAB	QAB	RAB
			Description	Grayish Brown	Reddish Black	Black	Silver	Gray	Dark Red	White	Dark Blue
			Paint type	M	M	2S	M	M	M	3P	M
			Hard clear coat	†	†	†	†	†	†	†	†
1	Bumper fascia		Body color	CAJ	GAD	KH3	K23	KAD	NAB	QAB	RAB
2	Front grille		Chrome	Cr2P	Cr2P	Cr2P	Cr2P	Cr2P	Cr2P	Cr2P	Cr2P
3	Door outside mirror	Base	Black	KH3	KH3	KH3	KH3	KH3	KH3	KH3	KH3
		Housing	Body color	CAJ	GAD	KH3	K23	KAD	NAB	QAB	RAB
4	Door outside handle		Chrome	Cr2P	Cr2P	Cr2P	Cr2P	Cr2P	Cr2P	Cr2P	Cr2P
5	Center mud-guard		Body color	CAJ	GAD	KH3	K23	KAD	NAB	QAB	RAB
6	License lamp finisher		Chrome	Cr2P	Cr2P	Cr2P	Cr2P	Cr2P	Cr2P	Cr2P	Cr2P

M= Metallic, S= Solid, 2S= Solid and Clear, 2P= 2-coat Pearl, 3P= 3-coat pearl, PM= Pearl metallic. Black is solvent based, all others are water based, † = Primerless diamond clear coat.

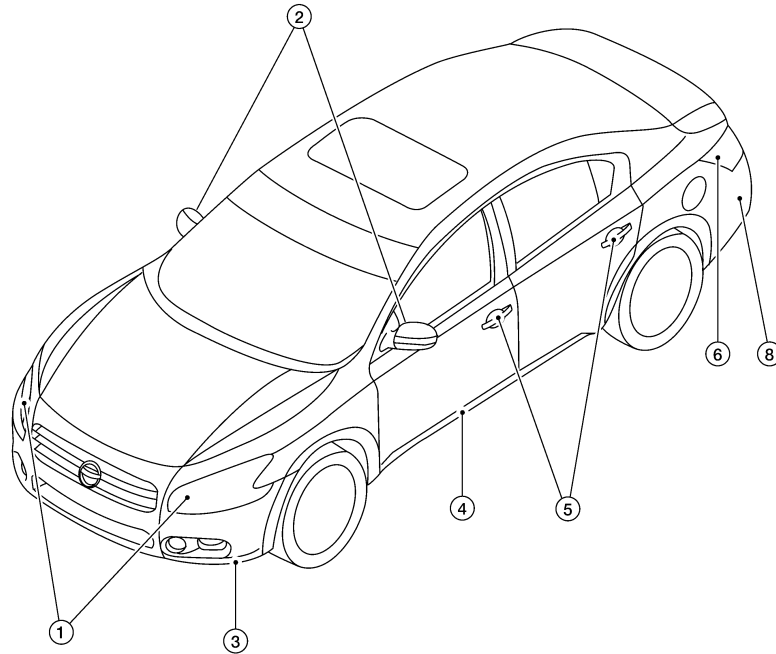
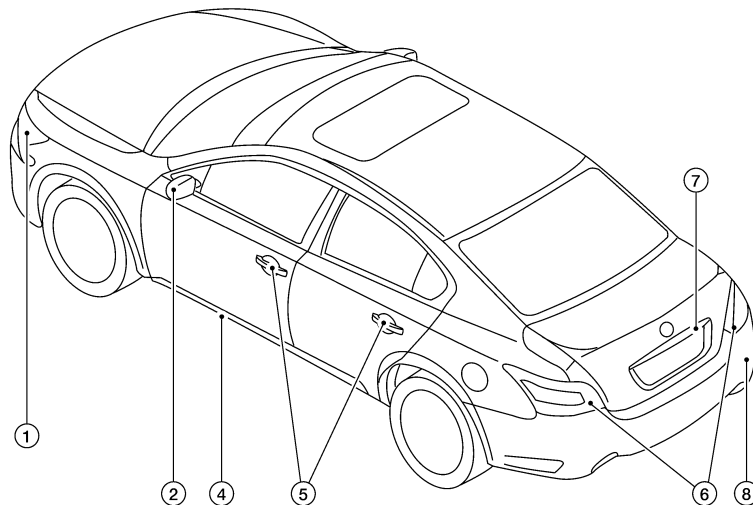
ALKIA1533GB

Item	Component	Abbreviation	Material
1.	Front combination lamp	Lens	PC Polycarbonate
		Housing	PP Polypropylene
2.	Door mirror	Base	PA Polyamide (Nylon)
		Housing	ABS Acrylonitrile Butadiene Styrene
3.	Front fascia	PP	Polypropylene

Item	Component	Abbreviation	Material	
4.	Mudguard	TPO	Thermoplastic Olefine	
5.	Outside door handle	Grip	PC	Polycarbonate
		Escutcheon	PA	Polyamide (Nylon)
6.	Rear combination lamp	Lens	PMMA	Poly Methyl Methacrylate
		Housing	ABS	Acrylonitrile Butadiene Styrene
7.	Trunk lid finisher	ABS + PC	Acrylonitrile Butadiene Styrene + Polycarbonate	
8.	Rear fascia	PP	Polypropylene

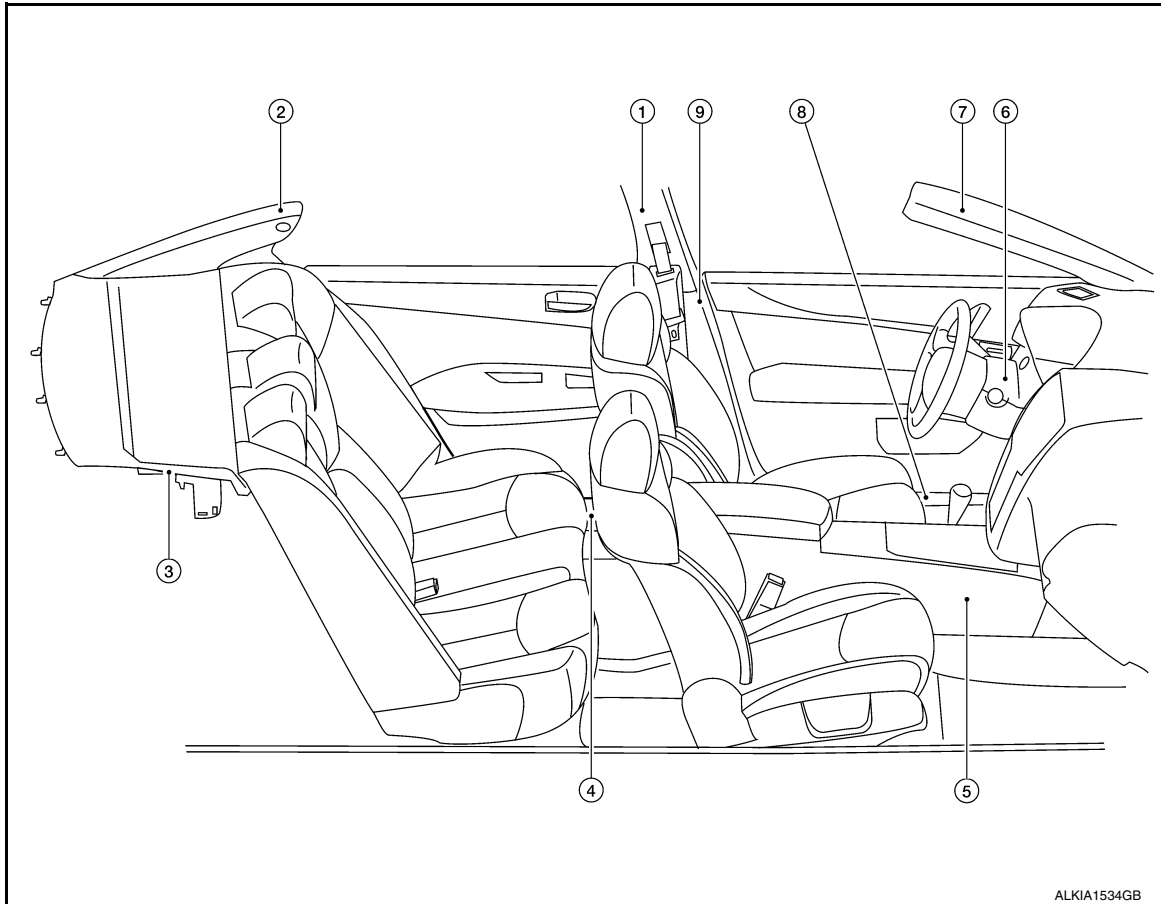
ALKIA1534GB

Item	Component	Abbreviation	Material	
1.	Center pillar upper finisher	core	PP	Polypropylene
		skin	PET	Polyester
2.	Rear pillar garnish	core	PP	Polypropylene
		skin	PET	Polyester
3.	Rear parcel shelf finisher	core	PP	Polypropylene
		skin	PET	Polyester
4.	Rear inner kicking plate	PP	Polypropylene	
5.	Center console	body	ABS + PC	Acrylonitrile Butadiene Styrene + Polycarbonate
		cup holder	ABS + PC	Acrylonitrile Butadiene Styrene + Polycarbonate
		storage bin	ABS + PC	Acrylonitrile Butadiene Styrene + Polycarbonate

Item	Component	Abbreviation	Material
6.	Steering column covers	PP	Polypropylene
7.	Front pillar upper finisher	core	Polypropylene
		skin	Polyester
8.	Front inner kicking plate	PP	Polypropylene
9.	Center pillar lower finisher	PP	Polypropylene

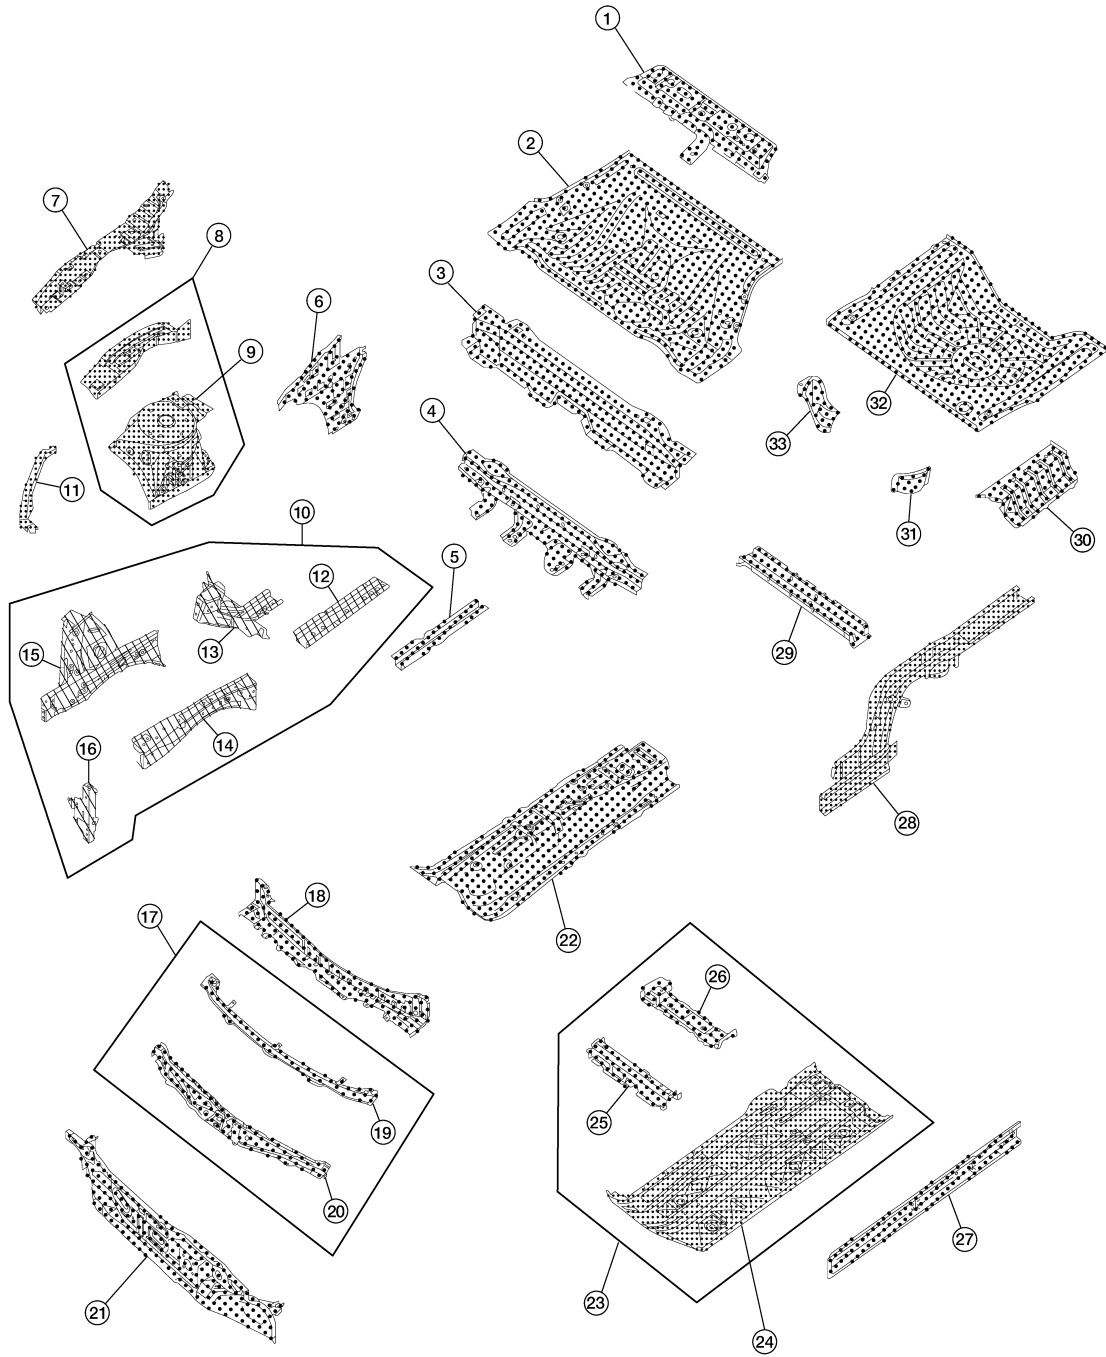
AWKIA1342GB

1. Rear seat lower crossmember	2. Rear floor front	3. Rear floor front extension	A
4. Rear seat crossmember	5. Front side member rear extension (LH/RH)	6. Dash side (LH/RH)

7. Hoodledge reinforcement (LH/RH)	8. Hoodledge lower assembly (LH/RH)	9. Front suspension spring support (LH/RH)	B
10. Front side member assembly (LH/RH)	11. Upper radiator core support (LH/RH)	12. Front side member center extension (LH/RH)

13. Front side member extension (LH/RH)	14. Front side member (LH/RH)	15. Closing plate assembly (LH/RH)	C
16. Radiator core side support (LH/RH)	17. Cowl top center assembly	18. Dash upper

19. Cowl top center	20. Dash lower	21. Front floor center assembly	D
22. Front floor assembly (LH/RH)	23. Front floor assembly (LH/RH)	24. Front floor (LH/RH)

25. 2nd crossmember assembly (LH/RH)	26. 3rd crossmember assembly (LH/RH)	27. Sill inner assembly (LH/RH)	E
28. Rear side member assembly (LH/RH)	29. Rear center crossmember	30. Rear floor rear (LH/RH)

31. Rear floor reinforcement (LH)	32. Rear floor rear	33. Rear floor reinforcement (RH)	F

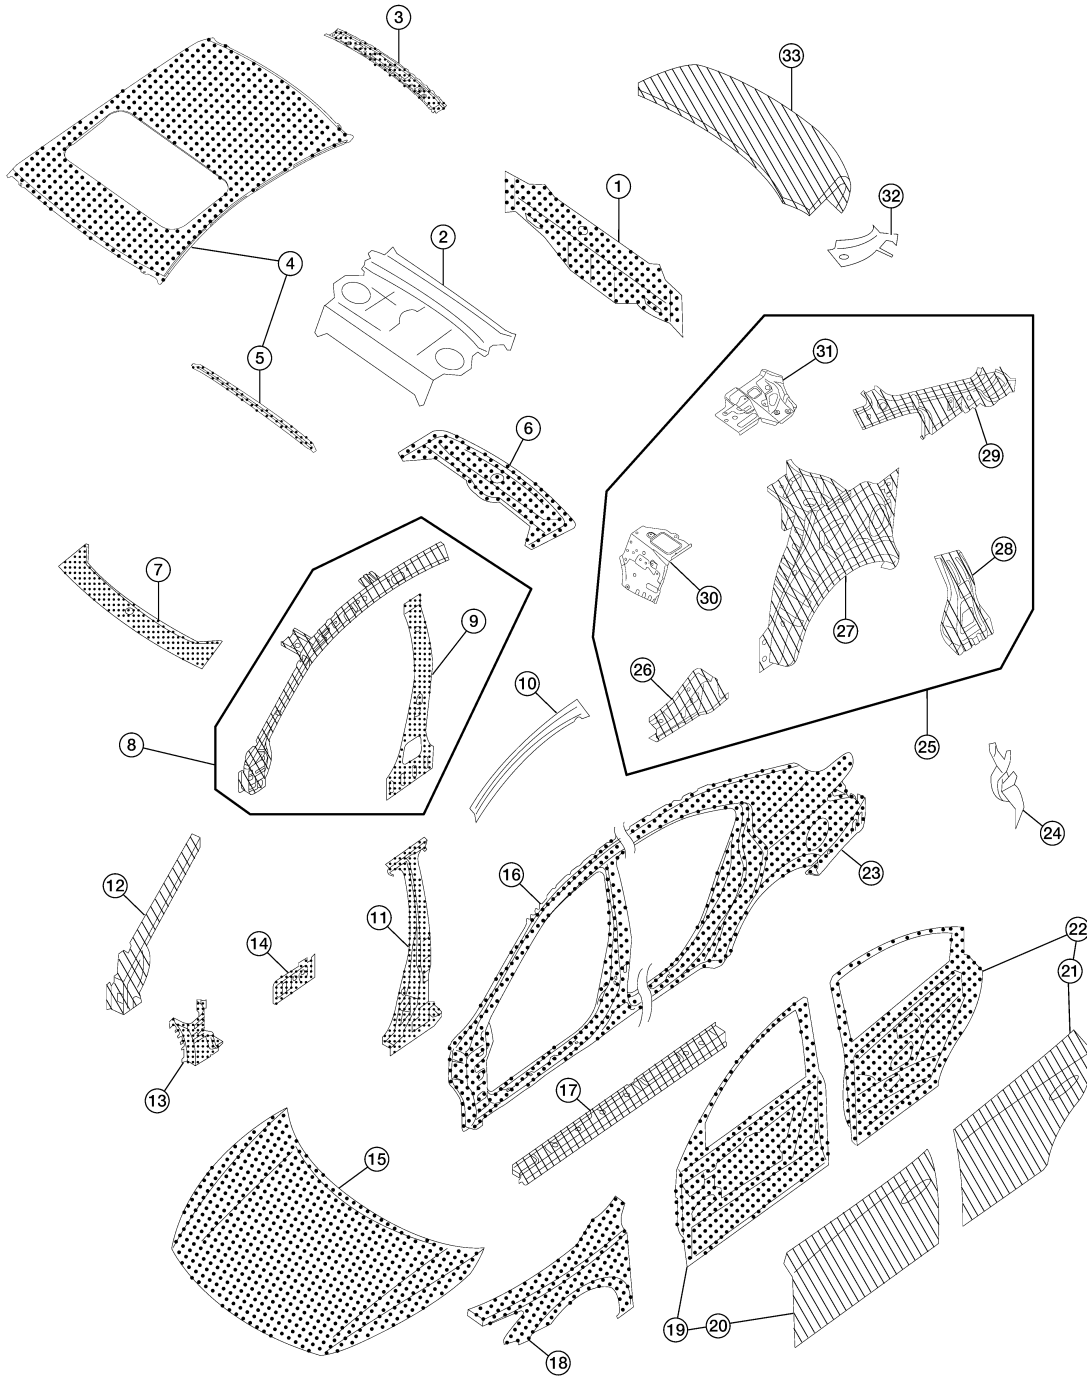
AWKIA1343GB

| 1. Rear panel assembly | 2. Parcel shelf assembly | 3. Rear roof rail assembly (single panel sunroof) |
| 4. Roof panel, single panel sunroof | 5. Rear roof bow | 6. Rear roof rail (dual panel sunroof) |
| 7. Front roof rail dual panel sunroof | 8. Body side inner reinforcement (LH/RH) | 9. Center pillar inner reinforcement (LH/RH) |

10. Roof side rail (LH/RH)	11. Center pillar reinforcement (LH/RH)	12. Front pillar upper hinge brace (LH/RH)	A
13. Front pillar lower hinge brace (LH/RH)	14. Front pillar lower reinforcement (LH/RH)	15. Hood assembly	
16. Front body side outer (LH/RH)	17. Outer sill reinforcement (LH/RH)	18. Front fender assembly (LH/RH)	B
19. front door assembly (LH/RH)	20. Front door outer (LH/RH)	21. Rear door outer (LH/RH)	
22. Rear door assembly (LH/RH)	23. Rear body side outer (LH/RH)	24. Tail lamp housing base (LH/RH)	
25. Rear body side inner assembly (LH/RH)	26. Sill outer reinforcement rear (LH/RH)	27. Rear wheel housing assembly (LH/RH)	C
28. Rear pillar inner reinforcement (LH/RH)	29. Rear pillar inner (LH/RH)	30. Rear seatback side support (LH/RH)	
31. Parcel shelf side (LH/RH)	32. Rear fender extension (LH/RH)	33. Trunk lid assembly	D

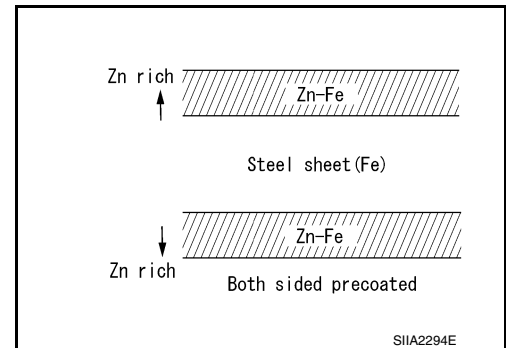
To improve repairability and corrosion resistance, a new type of anti-corrosive precoated steel sheet has been adopted replacing conventional zinc-coated steel sheet.

Galvannealed steel is electroplated and heated to form Zinc-iron alloy, which provides excellent and long term corrosion resistance with cationic electrodeposition primer.

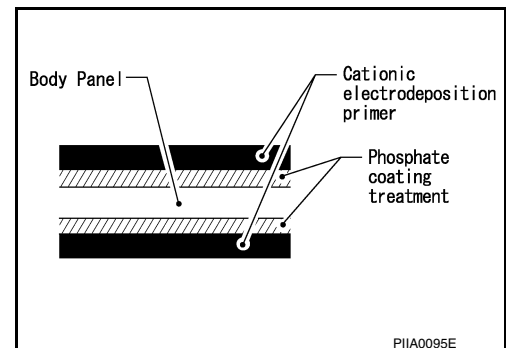
A phosphate coating treatment and a cationic electrodeposition primer, which provide excellent corrosion protection, are employed on all body components.

Confine paint removal during welding operations to an absolute minimum.

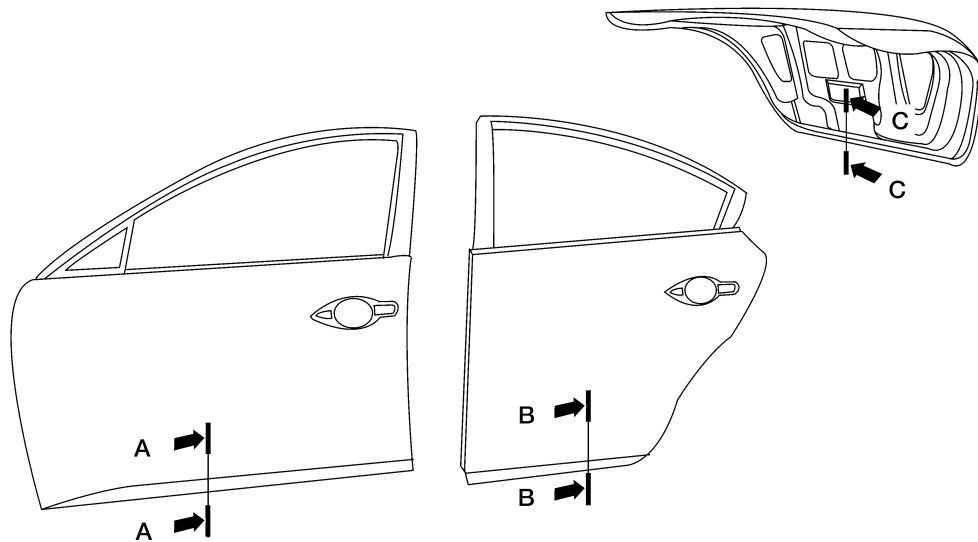
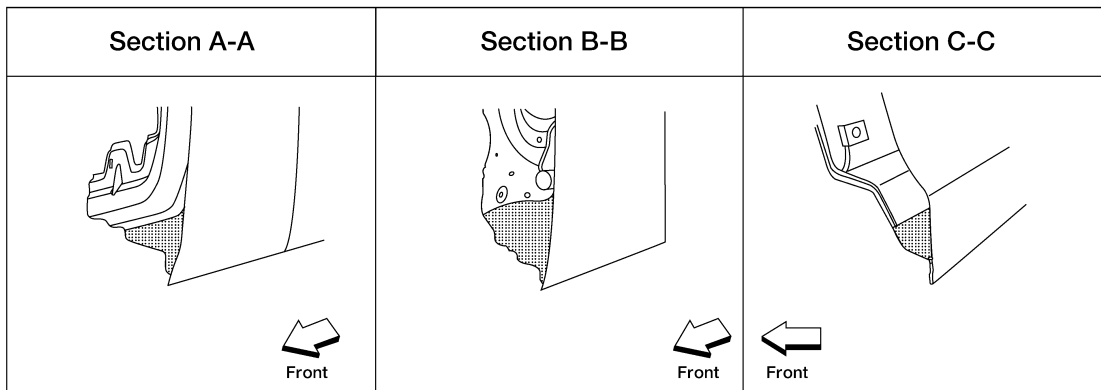
AWKIA1344GB

To improve corrosion resistance, anti-corrosive wax is applied inside the body sill and inside other closed sections. Accordingly, when replacing these parts, be sure to apply anti-corrosive wax to the appropriate areas of

: Indicates anti-corrosive wax coated portions

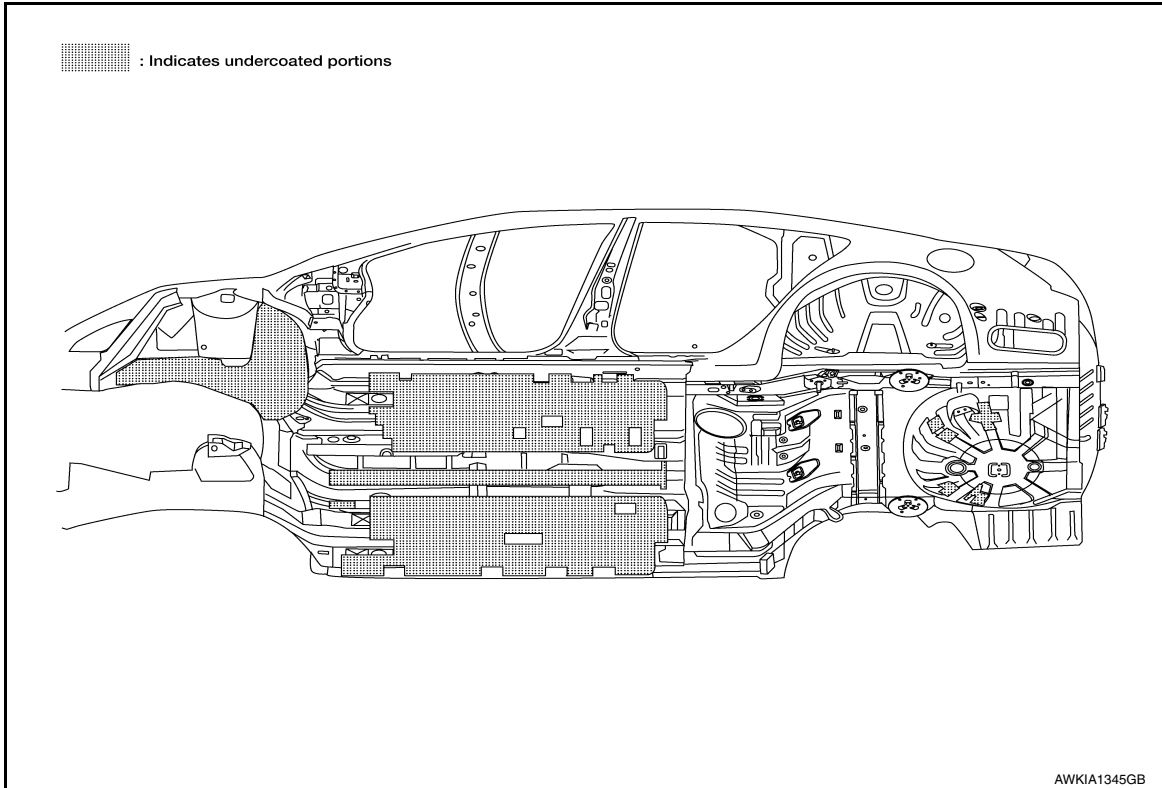
The underside of the floor and wheelhouse are undercoated to prevent rust, vibration, noise and stone chipping. Therefore, when such a panel is replaced or repaired, apply undercoating to that part. Use an undercoating which is rust preventive, soundproof, vibration-proof, shock-resistant, adhesive, and durable.

1. Do not apply undercoating to any place unless specified (such as the areas above the muffler and three way catalyst which are subjected to heat).
2. Do not undercoat the exhaust pipe or other parts which become hot.
3. Do not undercoat rotating parts.
4. Apply bitumen wax after applying undercoating.

5. After putting seal on the vehicle, put undercoating on it.

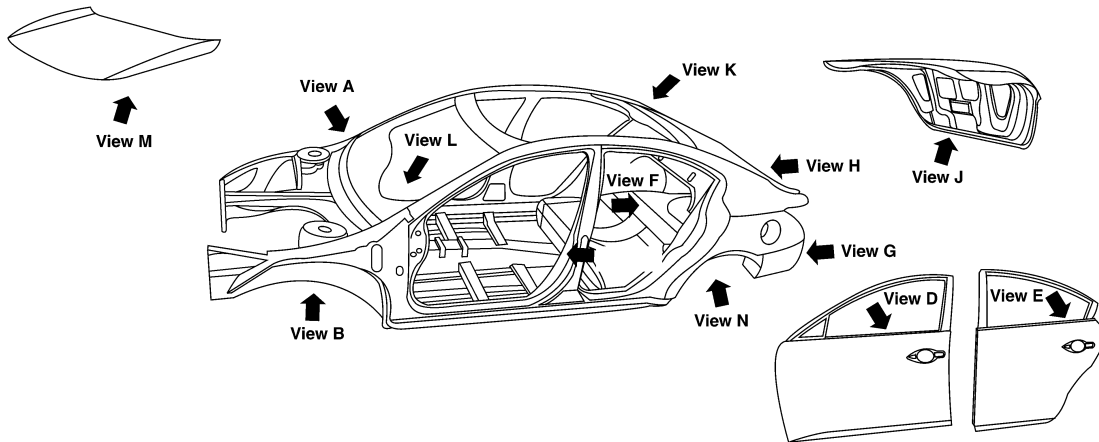
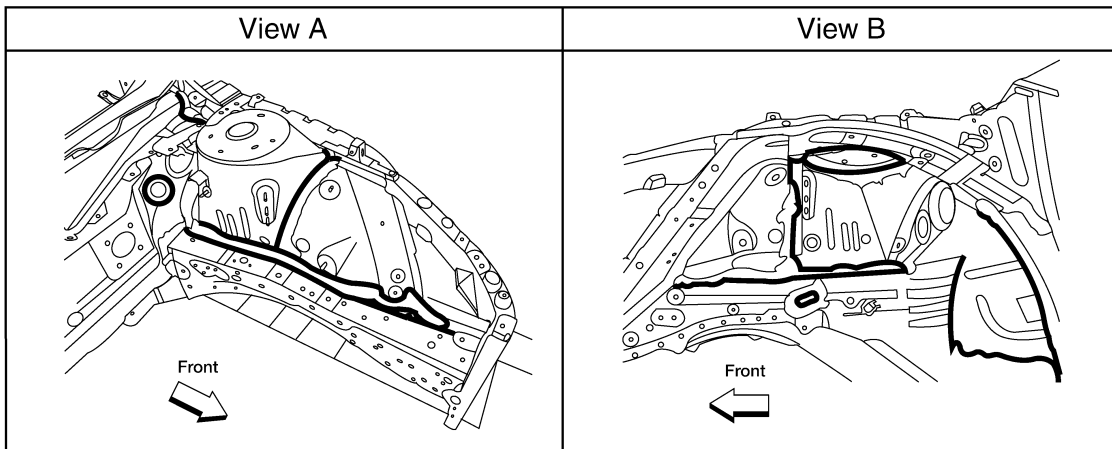
AWKIA1346GB

The following figure shows the areas which are sealed at the factory. Sealant which has been applied to these areas should be smooth and free from cuts or gaps. Care should be taken not to apply an excess amount of sealant and not to allow other unaffected parts to come into contact with the sealant.

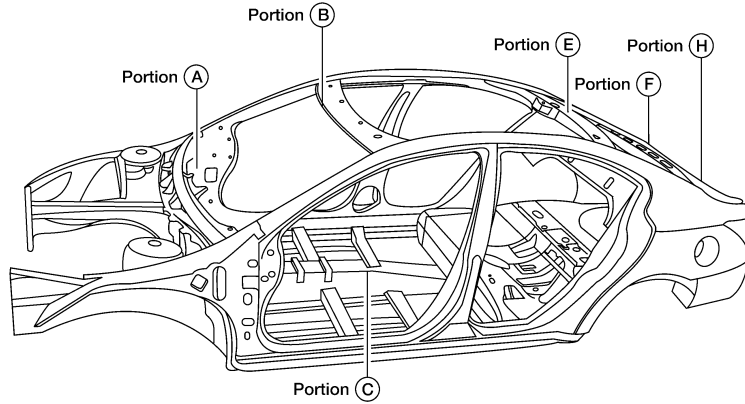
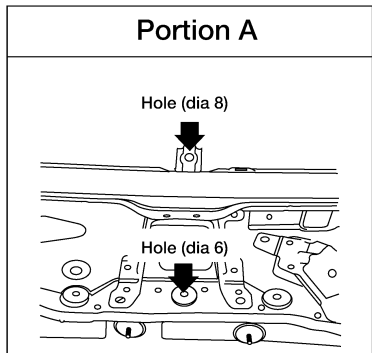
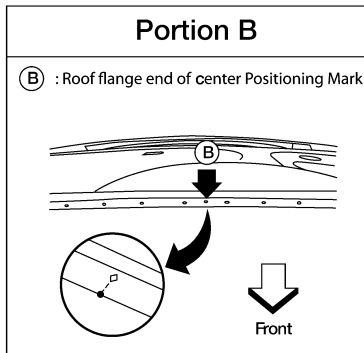
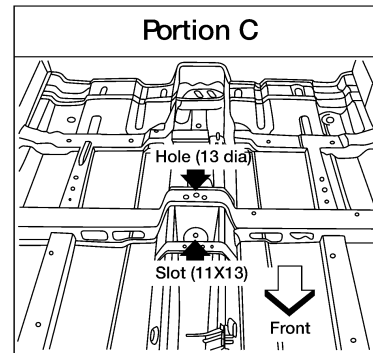
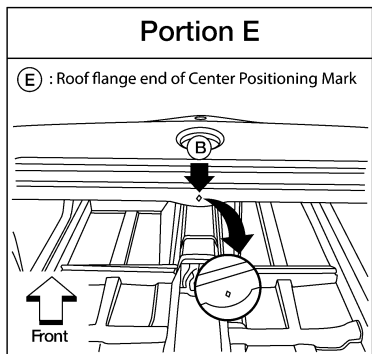
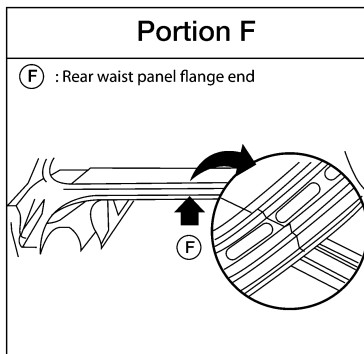
AWKIA1350GB

A mark has been placed on each part of the body to indicate the vehicle center. When repairing parts damaged by an accident which might affect the vehicle frame (members, pillars, etc.), more accurate and effective repair will be possible by using these marks together with body alignment specifications.

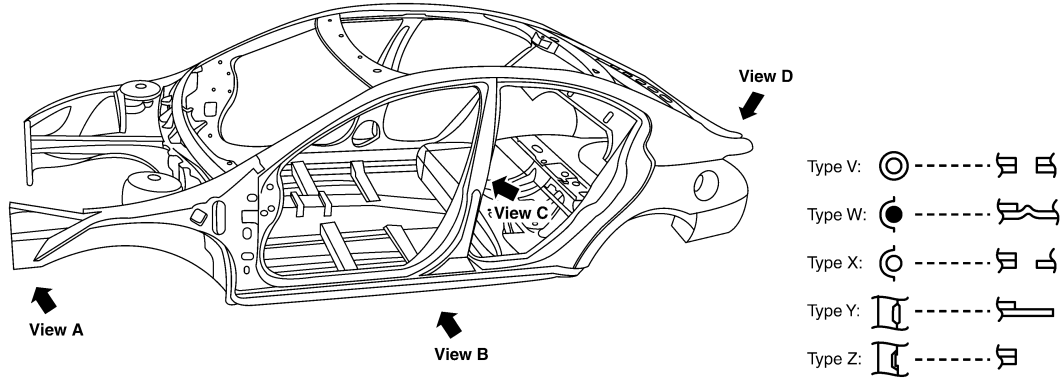
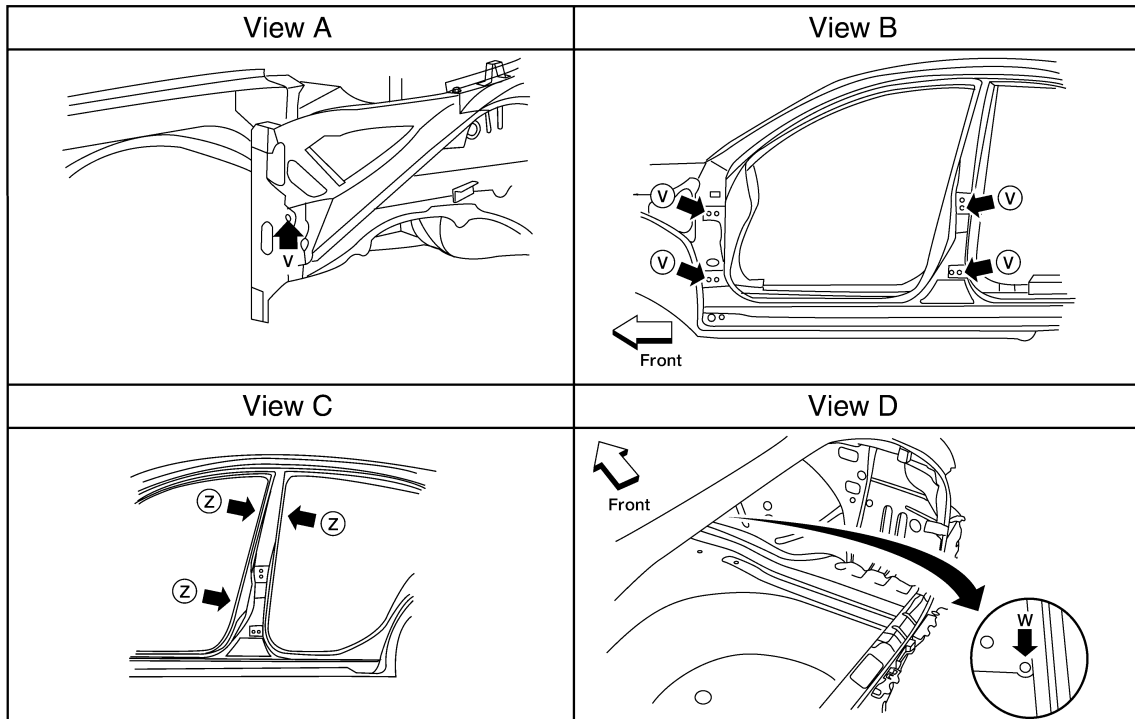
AWKIA1351GB

A mark has been placed on each body panel to indicate the parts matching positions. When repairing parts damaged by an accident which might affect the vehicle structure (members, pillars, etc.), more accurate and effective repair will be possible by using these marks together with body alignment specifications.

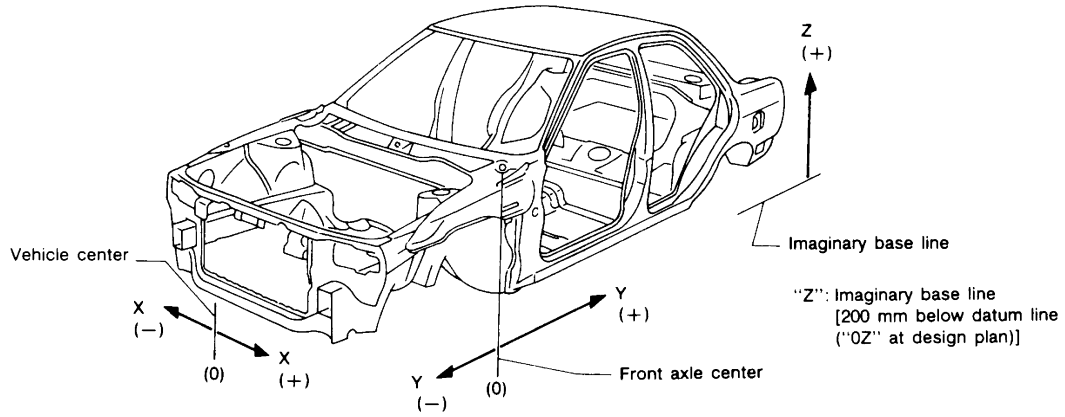
PIIA0104E

- All dimensions indicated in the figures are actual.
- When using a tracking gauge, adjust both pointers to equal length. Then check the pointers and gauge itself to make sure there is no free play.
- When a measuring tape is used, check to be sure there is no elongation, twisting or bending.
- Measurements should be taken at the center of the mounting holes.
- An asterisk (*) following the value at the measuring point indicates that the measuring point on the other side is symmetrically the same value.
- The coordinates of the measurement points are the distances measured from the standard line of "X", "Y" and "Z".

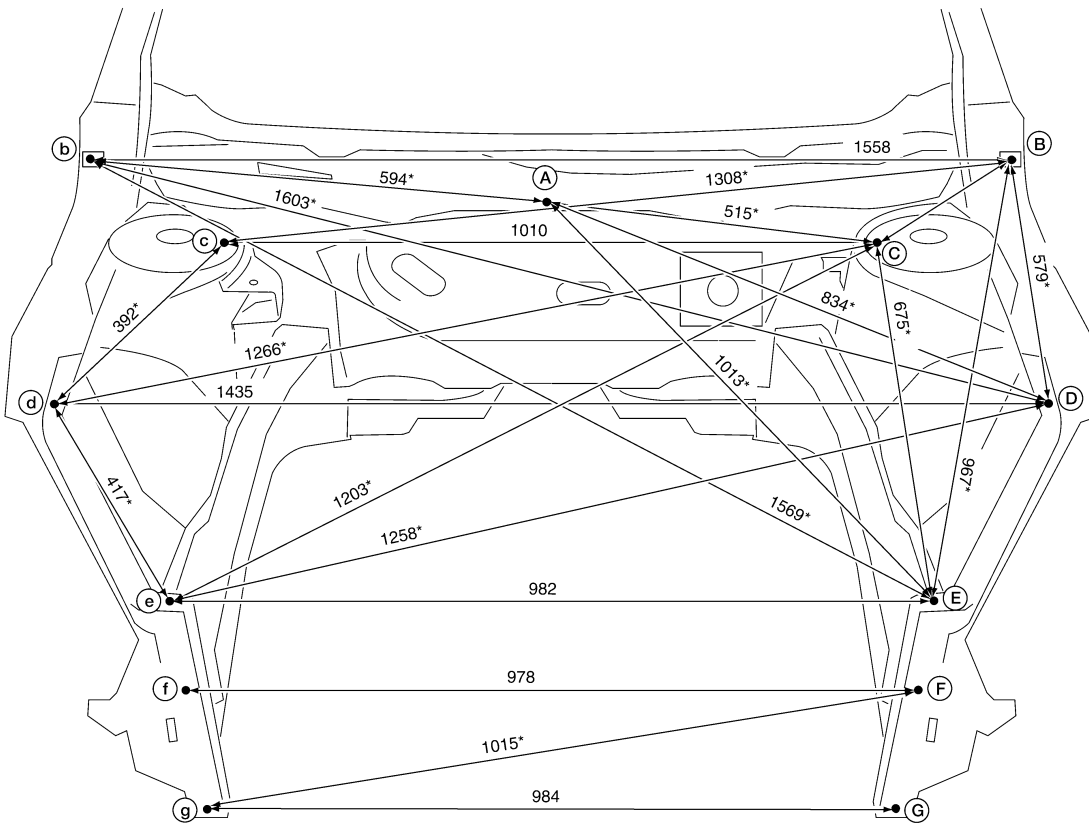
AWKIA1352GB

Figures marked with a (*) indicate symmetrically identical dimensions on both right and left sides of the vehicle.

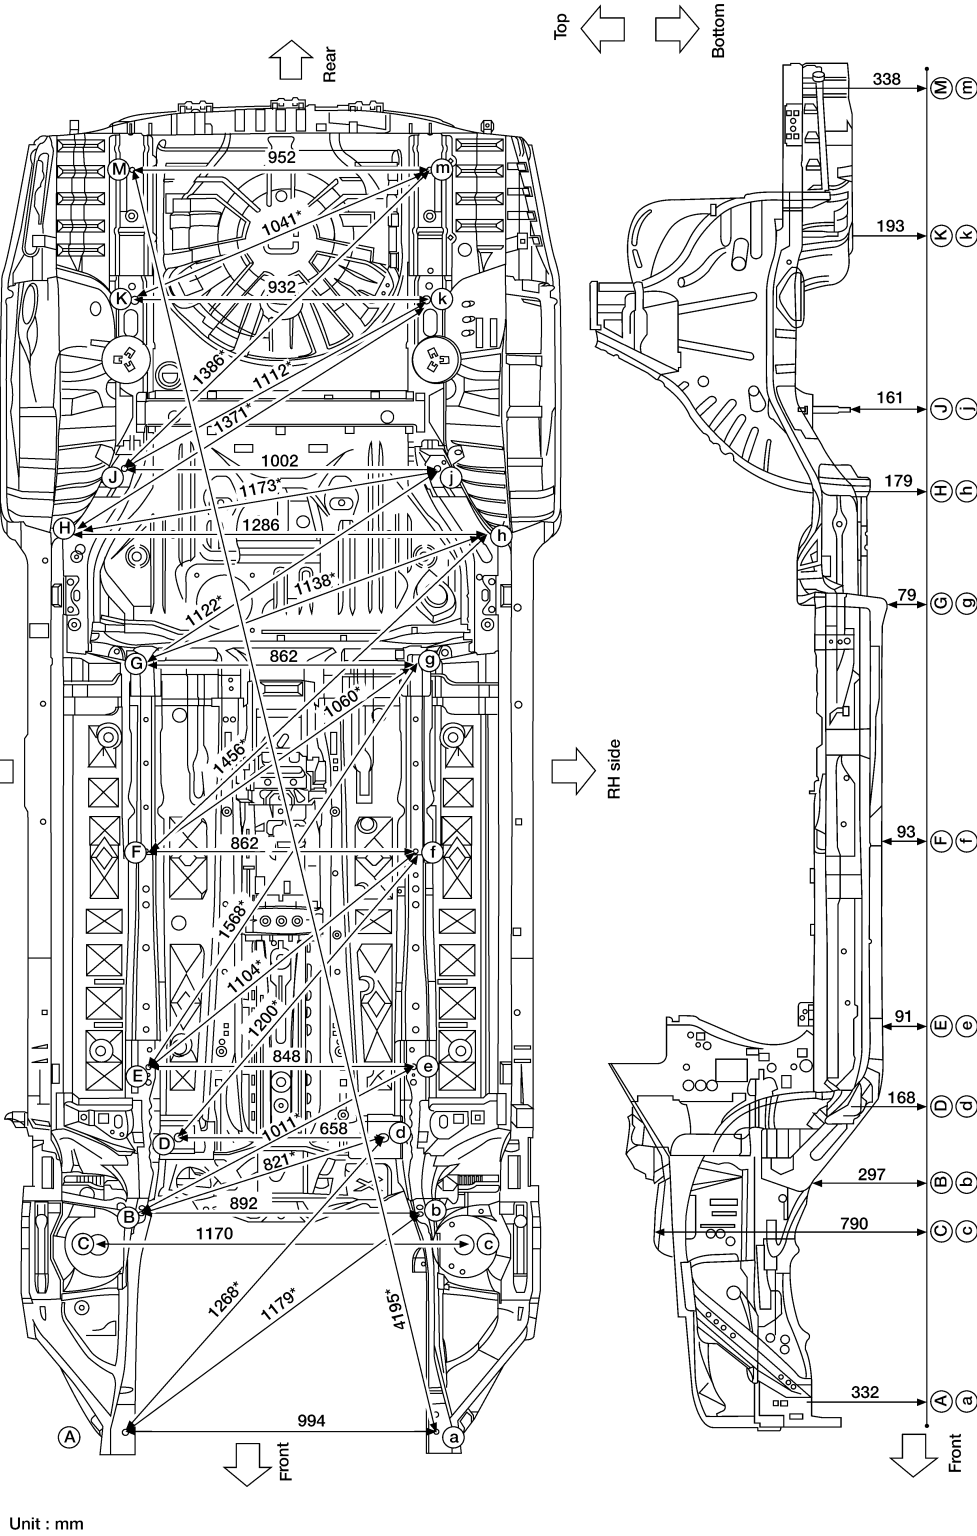
AWKIA1354GB

Figures marked with a (*) indicate symmetrically identical dimensions on both right and left hand sides of the vehicle.

As viewed from underside.

All dimensions indicated in this figure are actual.

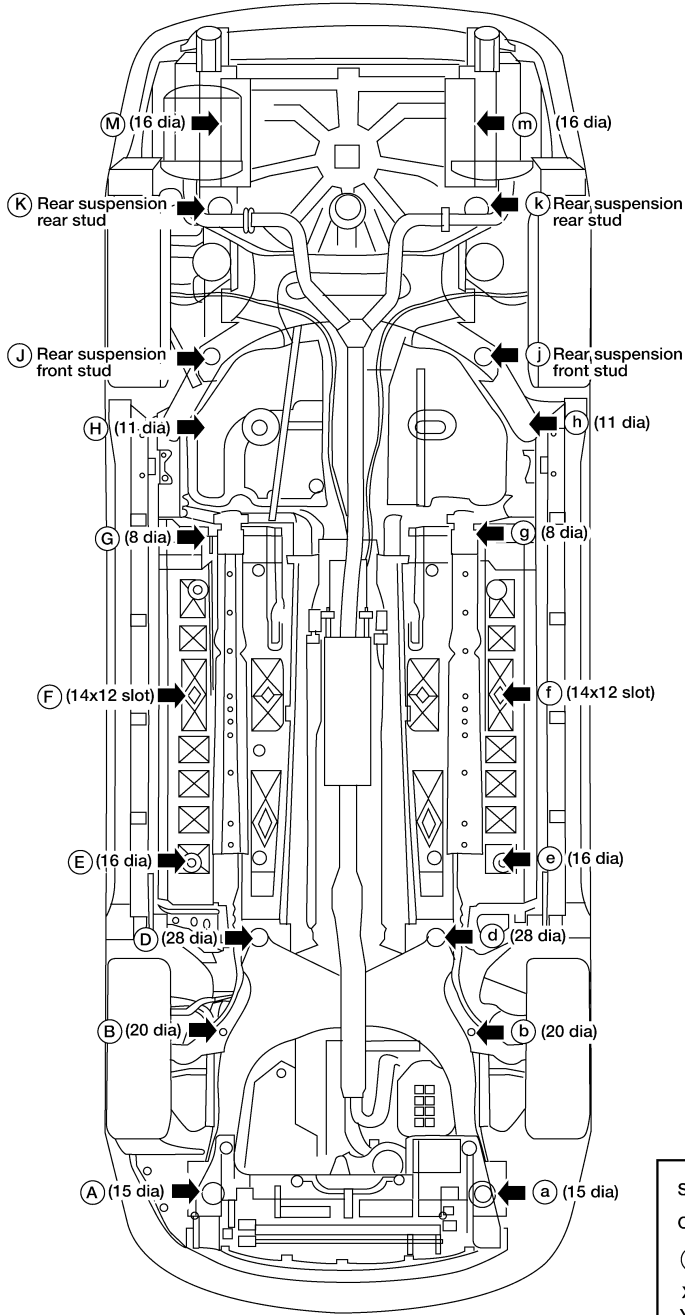
AWKIA1355GB

- (A) (a)
X : ± 497
Y : -556
Z : 332
- (B) (b)
X : ± 446
Y : 151
Z : 297
- (D) (d)
X : ± 327
Y : 395
Z : 168
- (E) (e)
X : ± 424
Y : 624
Z : 91
- (F) (f)
X : ± 431
Y : 1322
Z : 93
- (G) (g)
X : ± 431
Y : 1938
Z : 79
- (H) (h)
X : ± 643
Y : 2301
Z : 179
- (J) (j)
X : ± 501
Y : 2558
Z : 161
- (K) (k)
X : ± 466
Y : 3107
Z : 193
- (M) (m)
X : ± 476
Y : 3525
Z : 338

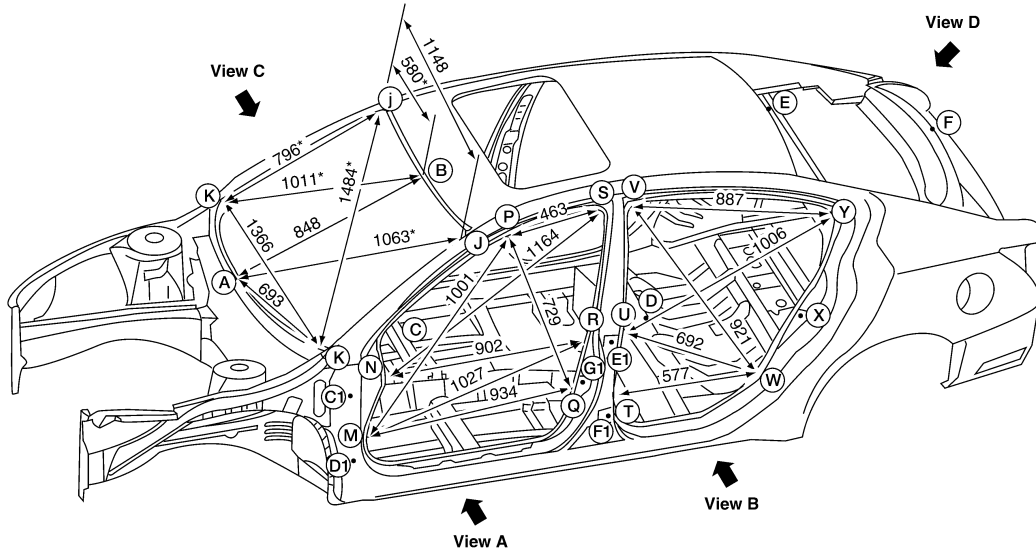
AWKIA1356GB

Figures marked with a (*) indicate symmetrically identical dimensions on both right and left sides of the vehicle.

Point	Dimension	Point	Dimension	Point	Dimension	Point	Dimension
(A) ~ (C)	999	(D) ~ (T)	742	(Gt) ~ (X)	875	(S) ~ (Q)	730
(A) ~ (D)	1842	(D) ~ (t)	742	(M) ~ (m)	1465	(S) ~ (s)	1501

(A) ~ (F)	2394	(D) ~ (u)	817	(M) ~ (P)	1001	(T) ~ (t)	1481
(B) ~ (C)	971	(D) ~ (U)	817	(M) ~ (q)	1079	(T) ~ (V)	801
(C) ~ (E)	1806	(D) ~ (v)	1039	(M) ~ (r)	1148*	(T) ~ (y)	1157*

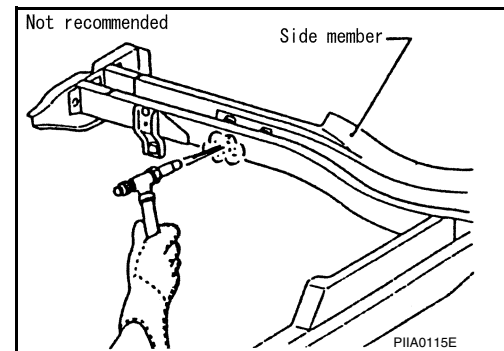
- The repair of reinforcements (such as side members) by heating is not recommended since it may weaken the component. When heating is unavoidable, do not heat HSS parts above 550°C (1,022°F). Verify heating temperature with a thermometer. (Crayon-type and other similar type thermometer are appropriate.)

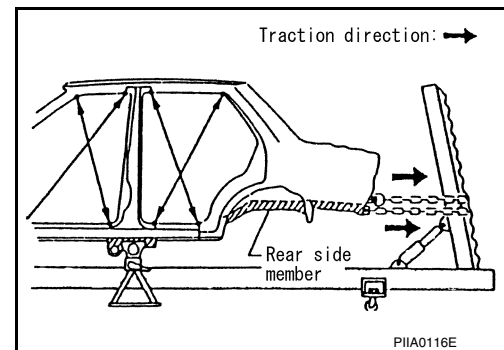
- When straightening body panels, use caution in pulling any HSS panel. Because HSS is very strong, pulling may cause deformation in adjacent portions of the body. In this case, increase the number of measuring points, and carefully pull the HSS panel.

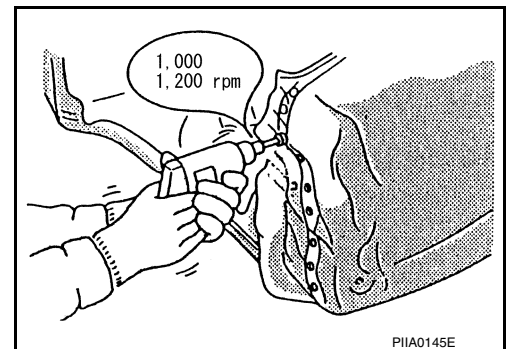
- The spot weld on HSS panels is harder than that of an ordinary steel panel. Therefore, when cutting spot welds on a HSS panel, use a low speed high torque drill (1,000 to 1,200 rpm) to increase drill bit durability and facilitate the operation.

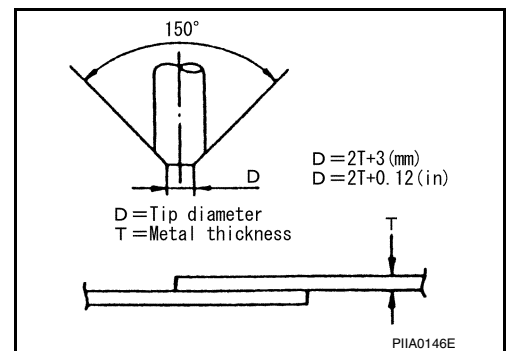
- The electrode tip diameter must be sized properly according to the metal thickness.

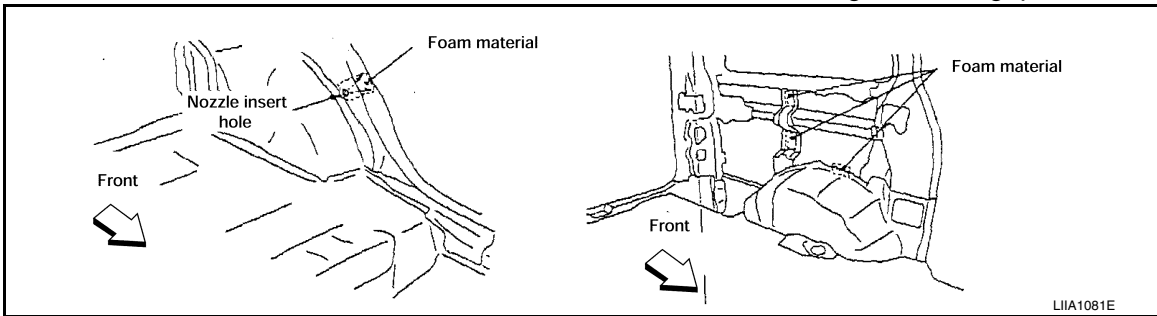
- Clean area in which foam was removed.
- Install service part.
- Insert nozzle into hole near fill area and fill foam material or fill in enough to close gap with service part.
